Notice 96-001

It has come to the attention of the Foundation from field reports that the following backflow prevention assemblies have exhibited low or inconsistent differential pressure readings across their check valves. Additionally, individual check valves have been discovered stuck in the open position, in a few assemblies.

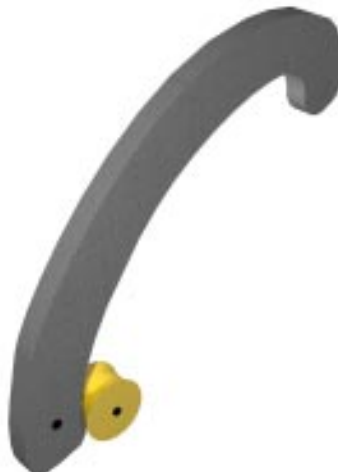
- Concentricity of clapper roller has been improved. Some of the previous production rollers were found to be non-concentric (i.e., the hole in the middle was not perfectly centered in the roller). The surface of the cam arm which rides against the roller has a buffed or polished finish.
