# ***Prevalence of Cross-Connections in Household Plumbing Systems***

***3 February 2004***

**UNIVERSITY OF SOUTHERN CALIFORNIA**

*Foundation for Cross-Connection Control  
and Hydraulic Research*

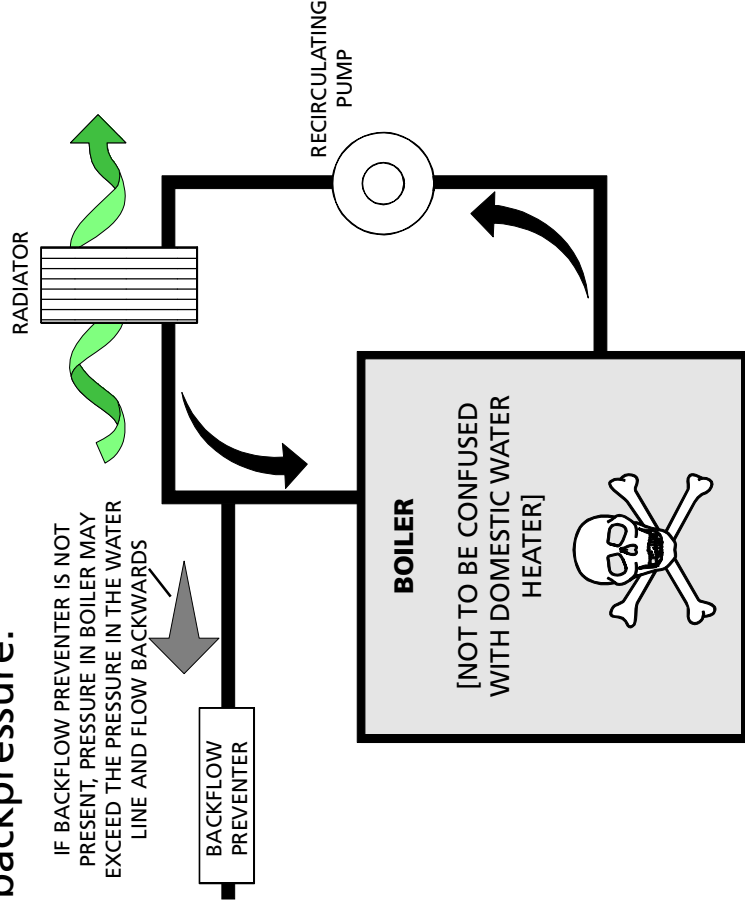
Due to the pressure that may build up inside of a boiler, the pressure of the boiler water may exceed that of the water feeding the boiler. The boiler water (which may be chemically treated with poisonous anti-corrosion compounds, etc.) may be pushed, or backpressured, into the make-up water line. This chemically contaminated water may be forced back into your home's potable water system, unless there is an appropriate backflow preventer that is designed for backpressure.
